WOODHOUSE DAY SPA
RENOVATION
MARKET STREET
9595 SIX PINES DRIVE
THE WOODLANDS, TEXAS 77680

PROJECT NO: 2019.0172
DATE: 04-08-2019

A3.6
MILLWORK DETAILS

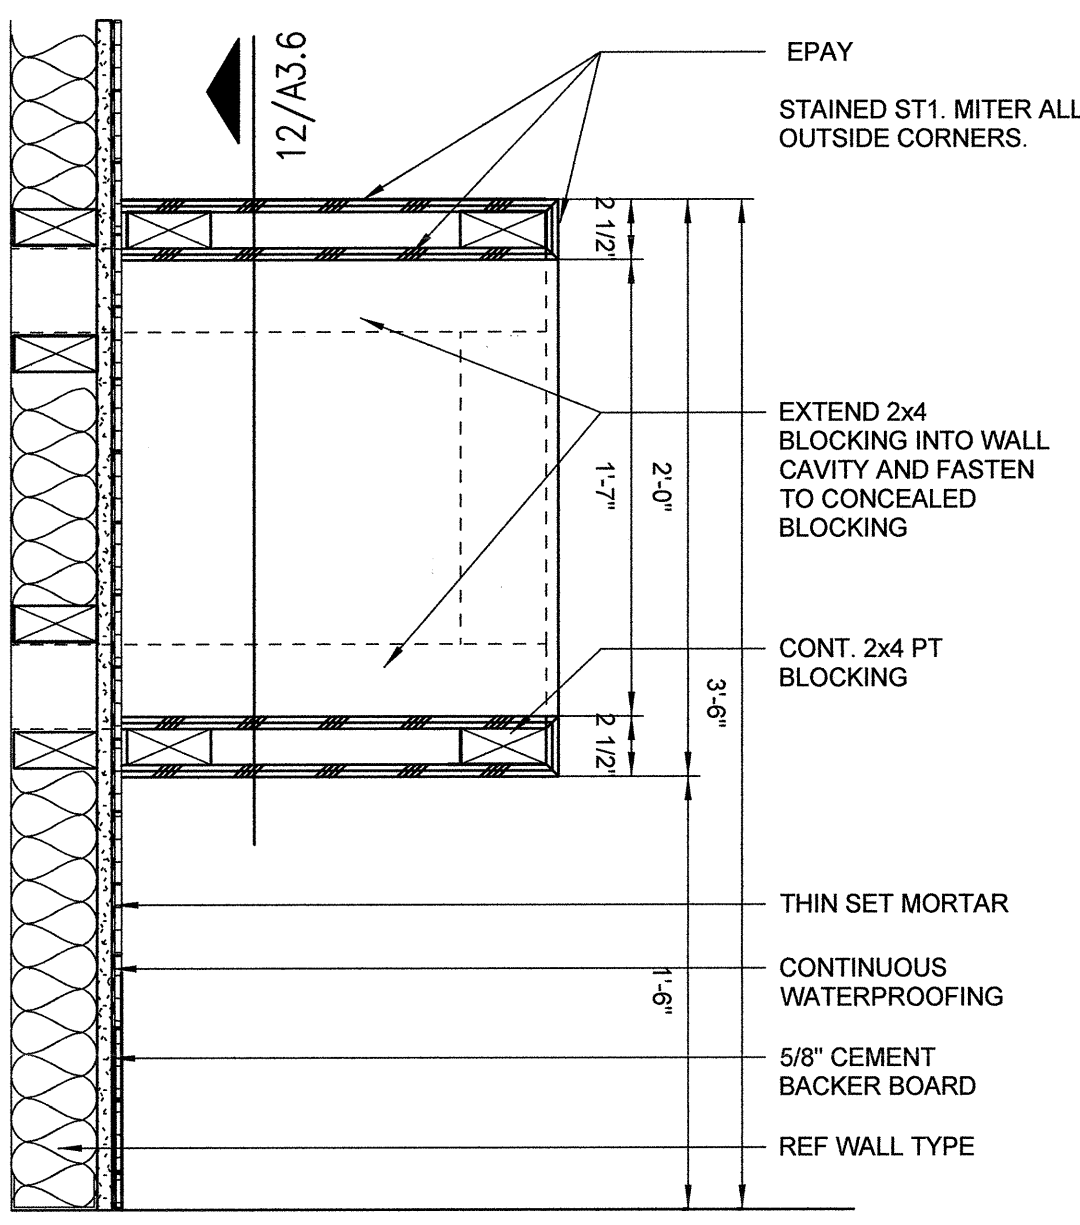
13 VICHY SHELFING 1-1/2" = 1'-0"

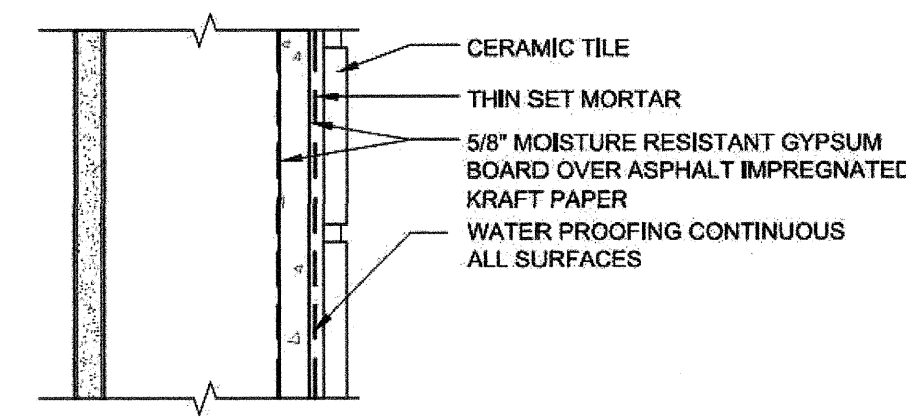
8 WATERPROOFING DETAIL NTS
WATERPROOFING MEMBRANE SYSTEM FOR
TOILET WALLS

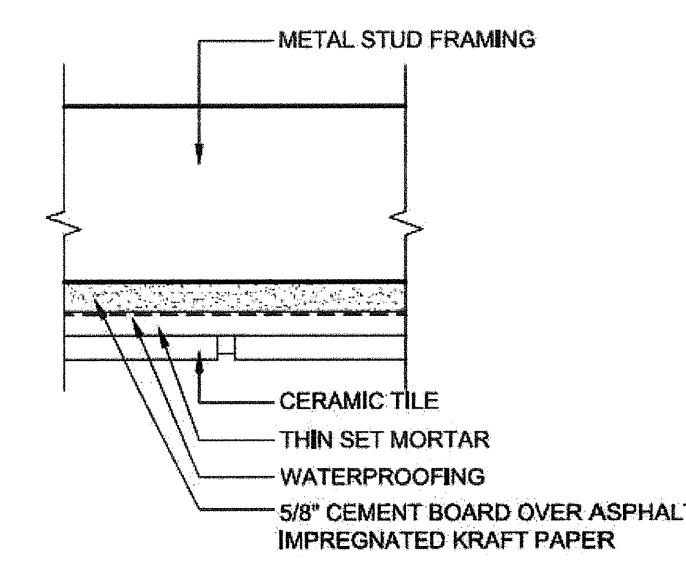
5 WATERPROOFING DETAIL NTS
WATERPROOFING MEMBRANE SYSTEM FOR
FLOOR IN SHOWER CHANGING AREA

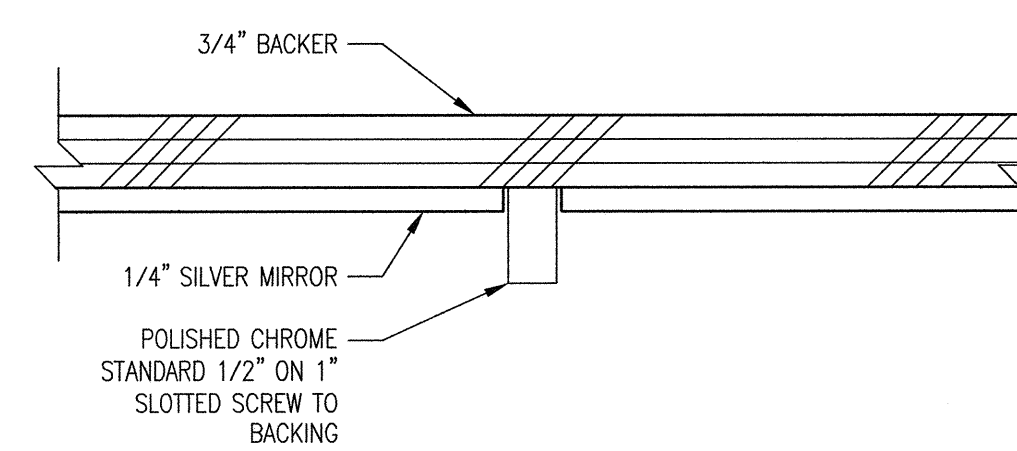
3 MIRROR DETAIL 3" = 1'-0"
